1. Please refer to the **Disclaimer** below.
2. Please review the associated project report before referring to the maps: Northwest Hydraulic Consultants Ltd. (NHC), 2023. 'Northwest Vancouver Island Tsunami Risk Assessment (Phase 2)'. Report prepared for Ocean Networks Canada. NHC project number 3006332.

**NORTHWEST VANCOUVER ISLAND
TSUNAMI RISK ASSESSMENT PROJECT**

**INUNDATION LEVEL FOR
EMERGENCY PLANNING
ALASKA TSUNAMI
MAP INDEX & NOTES**

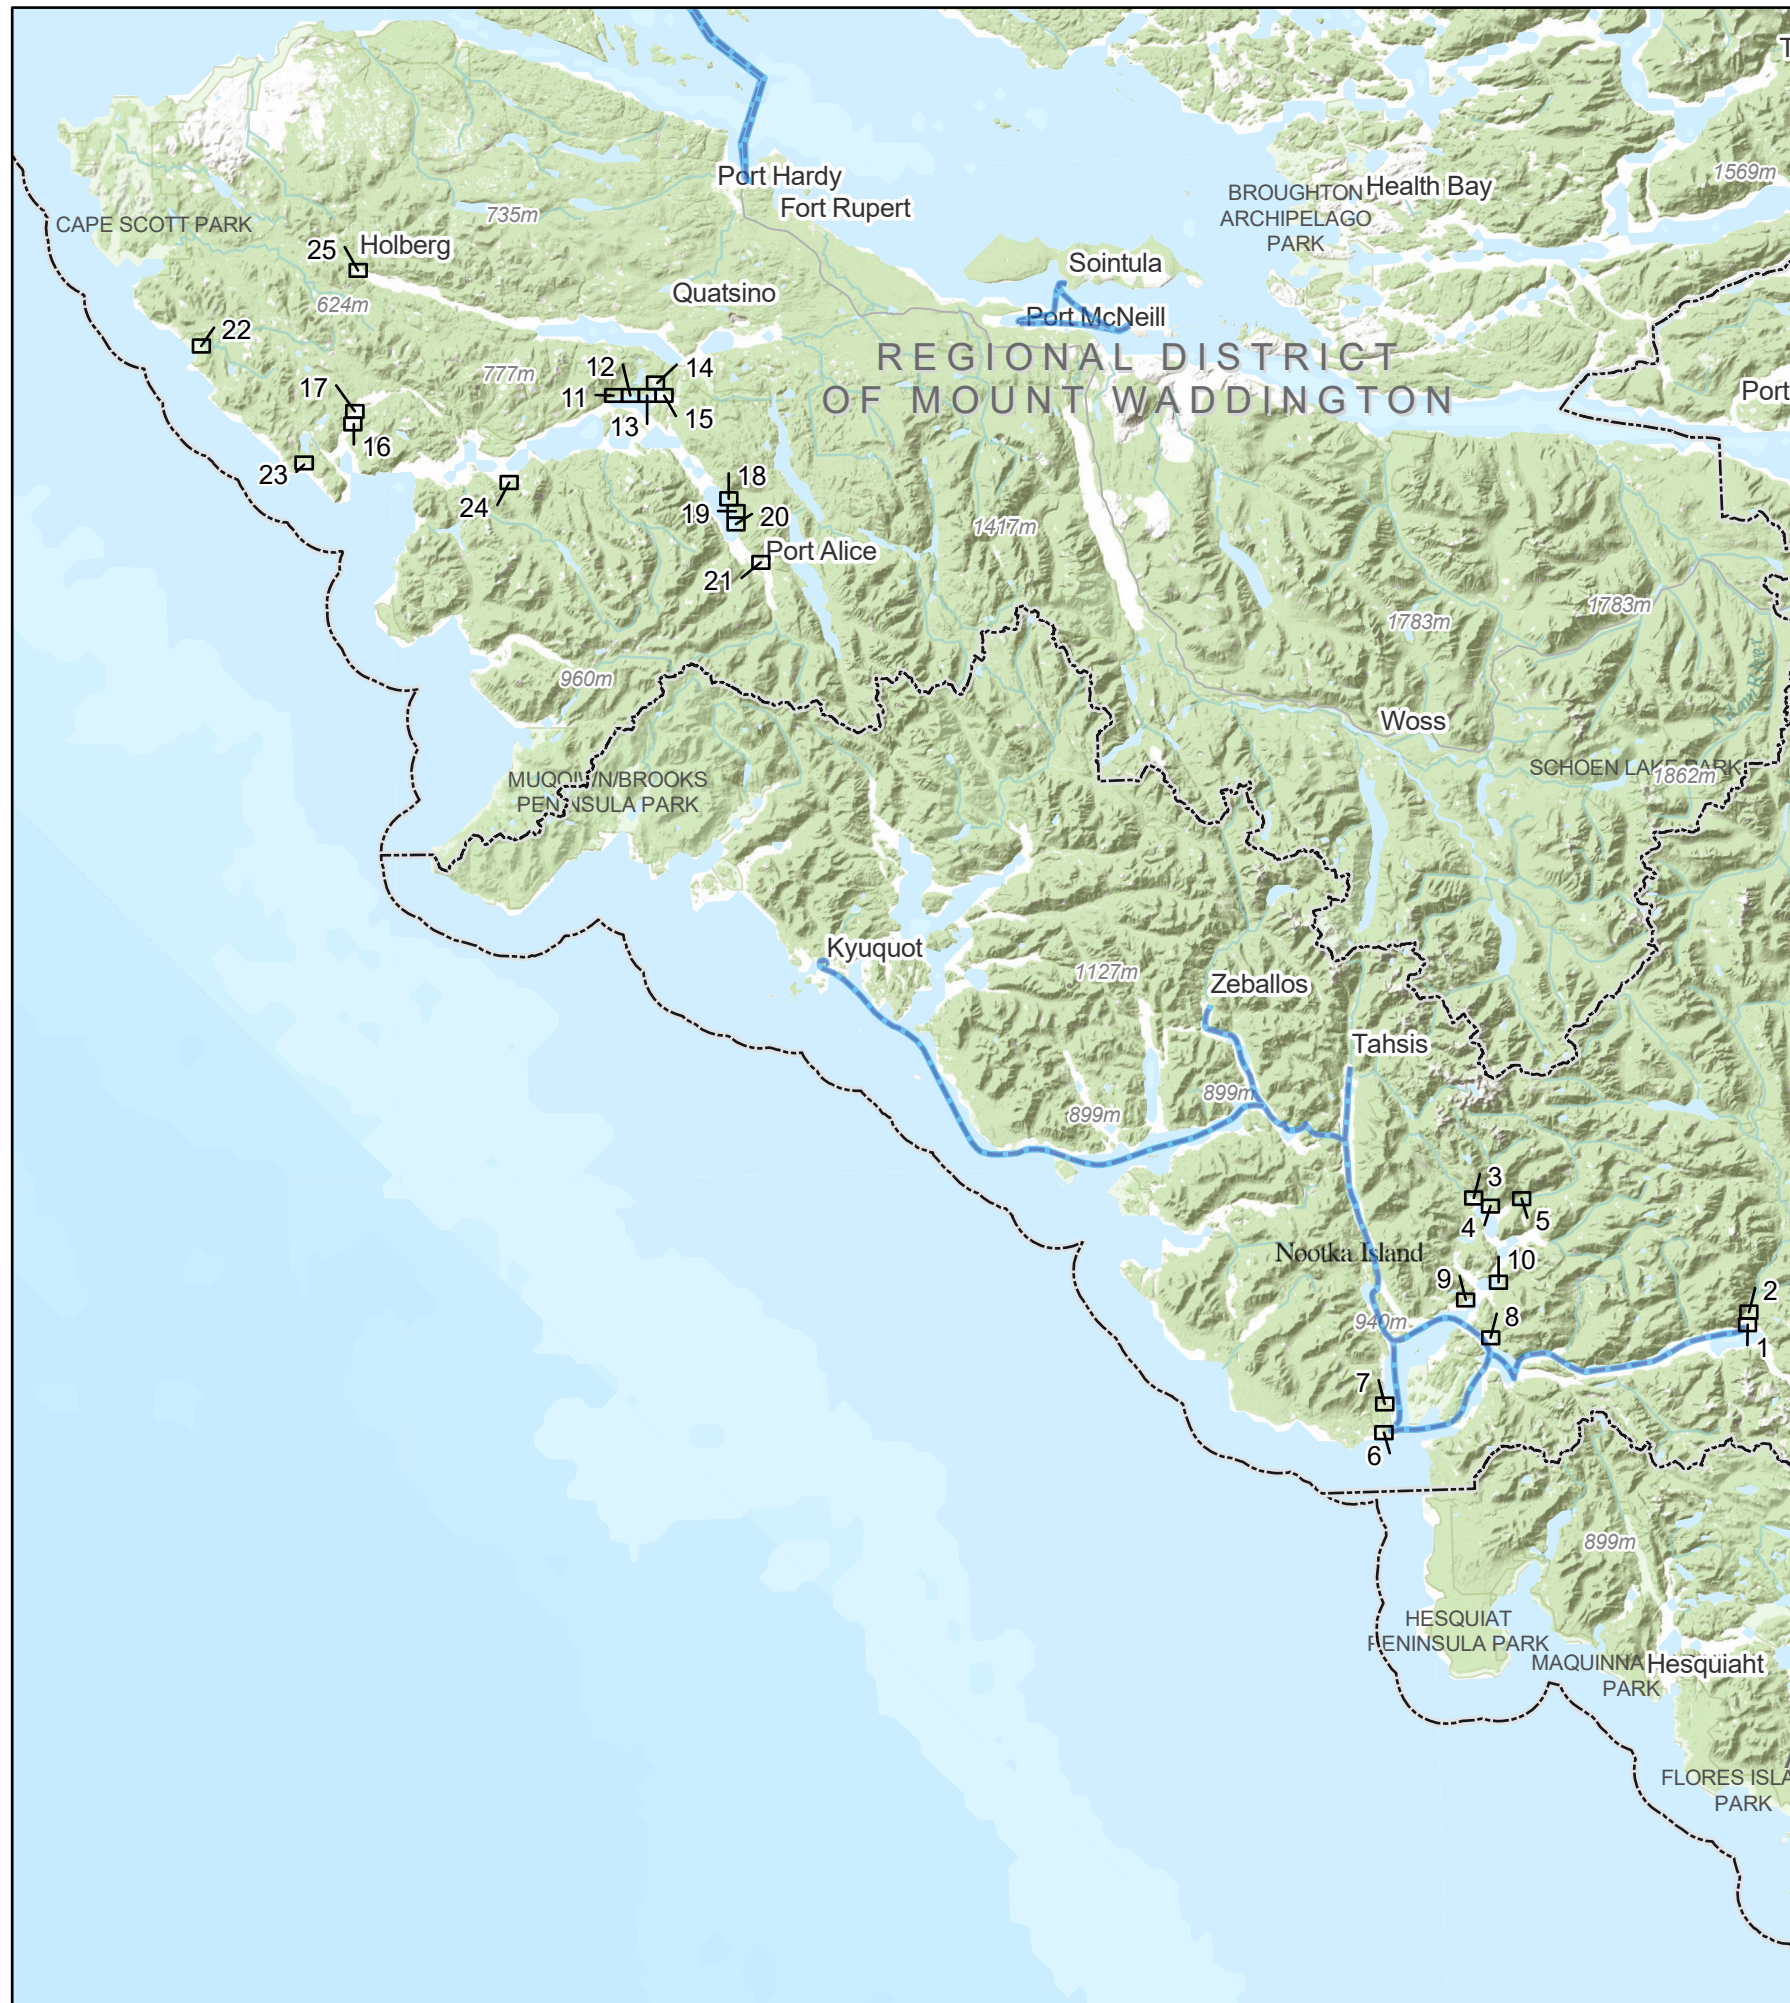
3. Tsunami model results shown correspond to an earthquake with a magnitude of 9.2 from the Alaska-Aleutian Subduction Zone. Please refer to the project report for additional information on tsunami source.

4. Initial water level for tsunami simulations consists of current-day Higher High Water Mean Tide (HHWMT) which at Winter Harbour and Gold River terminal correspond to an elevation of 1.5 m above the Canadian Geodetic Vertical Datum of 2013 (CGVD2013). HHWMT is defined as the average from all the higher high waters from 19 years of tidal predictions.

5. These maps show the tsunami inundation as predicted by the numerical model as well as the tsunami inundation level for emergency planning which includes a safety factor. This safety factor was applied by increasing by 50% the vertical distance of the maximum water surface above a reference plane corresponding to HHWMT. Inundation levels mapped do not include any freeboard or any setback.
