1. Please refer to the **Disclaimer** below.
2. Please review the associated project report before referring to the maps: Northwest Hydraulic Consultants Ltd. (NHC), 2023. 'Northwest Vancouver Island Tsunami Risk Assessment (Phase 2)'. Report prepared for Ocean Networks Canada. NHC project number 3006332.

3. Tsunami model results shown correspond to an earthquake with a magnitude of 9.0 from the Cascadia Subduction Zone. Please refer to the project report for additional information on tsunami source.

**NORTHWEST VANCOUVER ISLAND  
TSUNAMI RISK ASSESSMENT PROJECT**

**INUNDATION LEVEL FOR  
EMERGENCY PLANNING  
CASCADIA TSUNAMI  
MAP INDEX & NOTES**

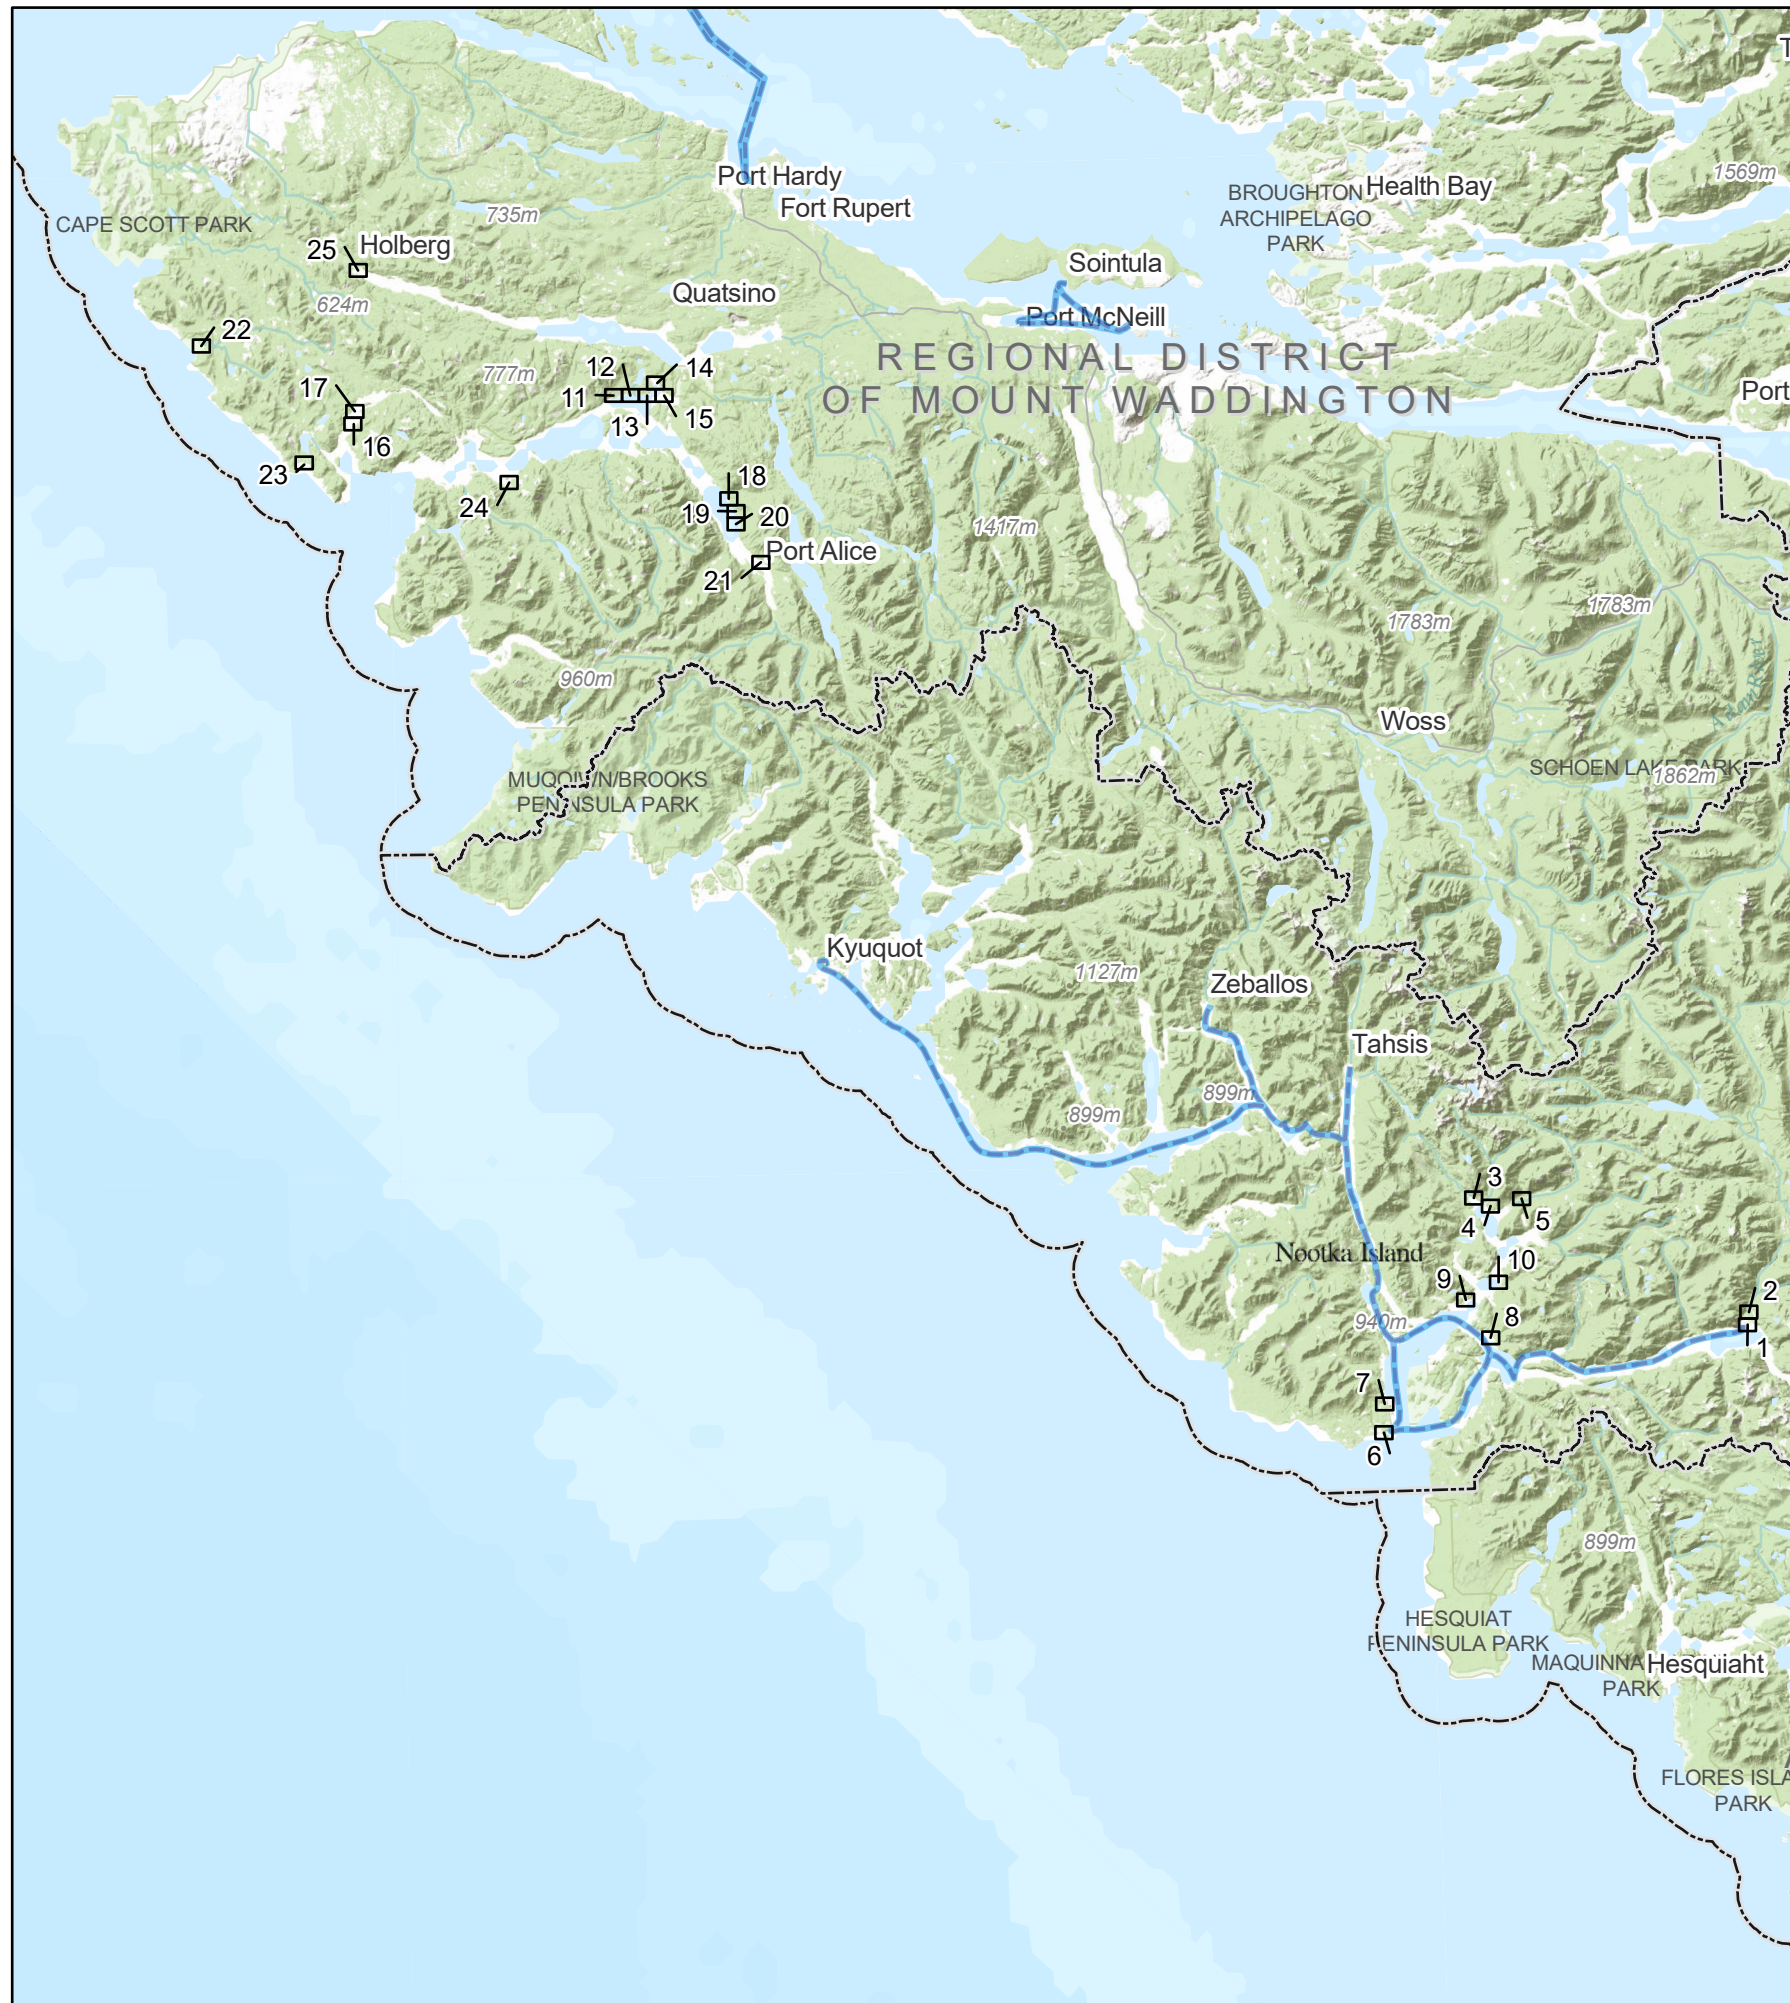
4. Initial water level for tsunami simulations consists of current-day Higher High Water Mean Tide (HHWMT) which at Winter Harbour and Gold River terminal correspond to an elevation of 1.5 m above the Canadian Geodetic Vertical Datum of 2013 (CGVD2013). HHWMT is defined as the average from all the higher high waters from 19 years of tidal predictions.

5. Spatially varying land subsidence and uplift associated to the Cascadia Subduction Zone earthquake has been applied by adjusting the underlying digital elevation model as per Natural Resources Canada information.

6. These maps show the tsunami inundation as predicted by the numerical model as well as the tsunami inundation level for emergency planning which includes a safety factor. This safety factor was applied by increasing by 50% the vertical distance of the maximum water surface above a reference plane corresponding to HHWMT. Inundation levels mapped do not include any freeboard or any setback.
